THORENS

SERVICE MANUAL

MODELS:	TD-145	Series I
	TD-160	Series I
	TD-165	Series I
	TD-145	MKII Isotrack
	TD-160	MKII Isotrack
	TD-166	MKII Isotrack

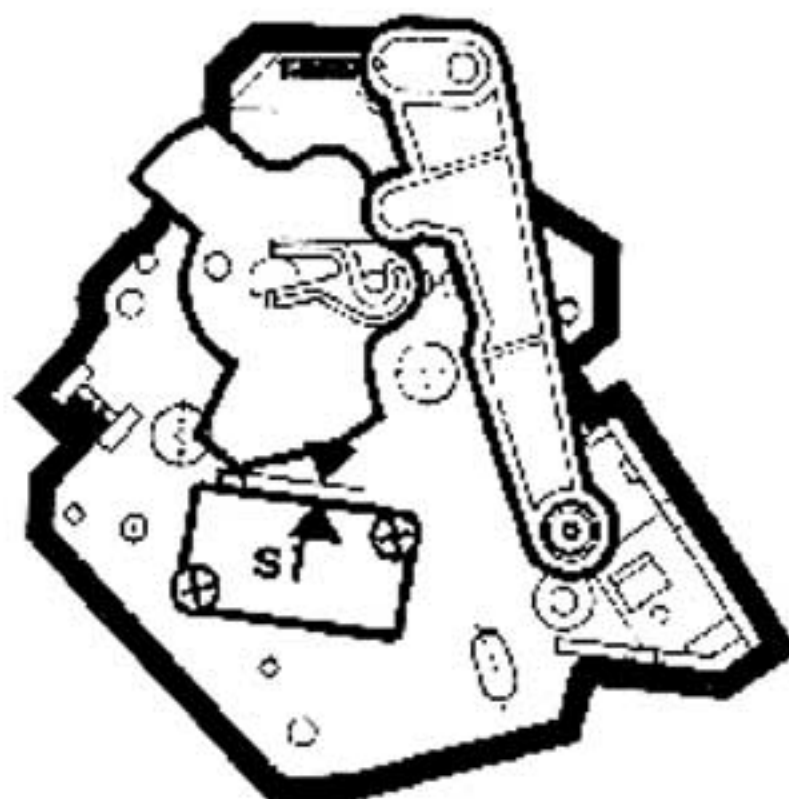
SERVICE ADJUSTMENTS

Switch adjustments; If it becomes necessary to adjust the switches, there is a defined value of clearance associated with each function switch.

Remove the hardboard bottom cover. The micro switch S-1 associated with the speed selection control must have a clearance of 0.8mm between the actuating arm and the body of the switch when the speed selection control is in the "STOP" position.
